Semi-Annual Environmental Monitoring Report

(January – June 2018)

Regional Urban Development Project (RUDP)

Biratnagar, Nepal

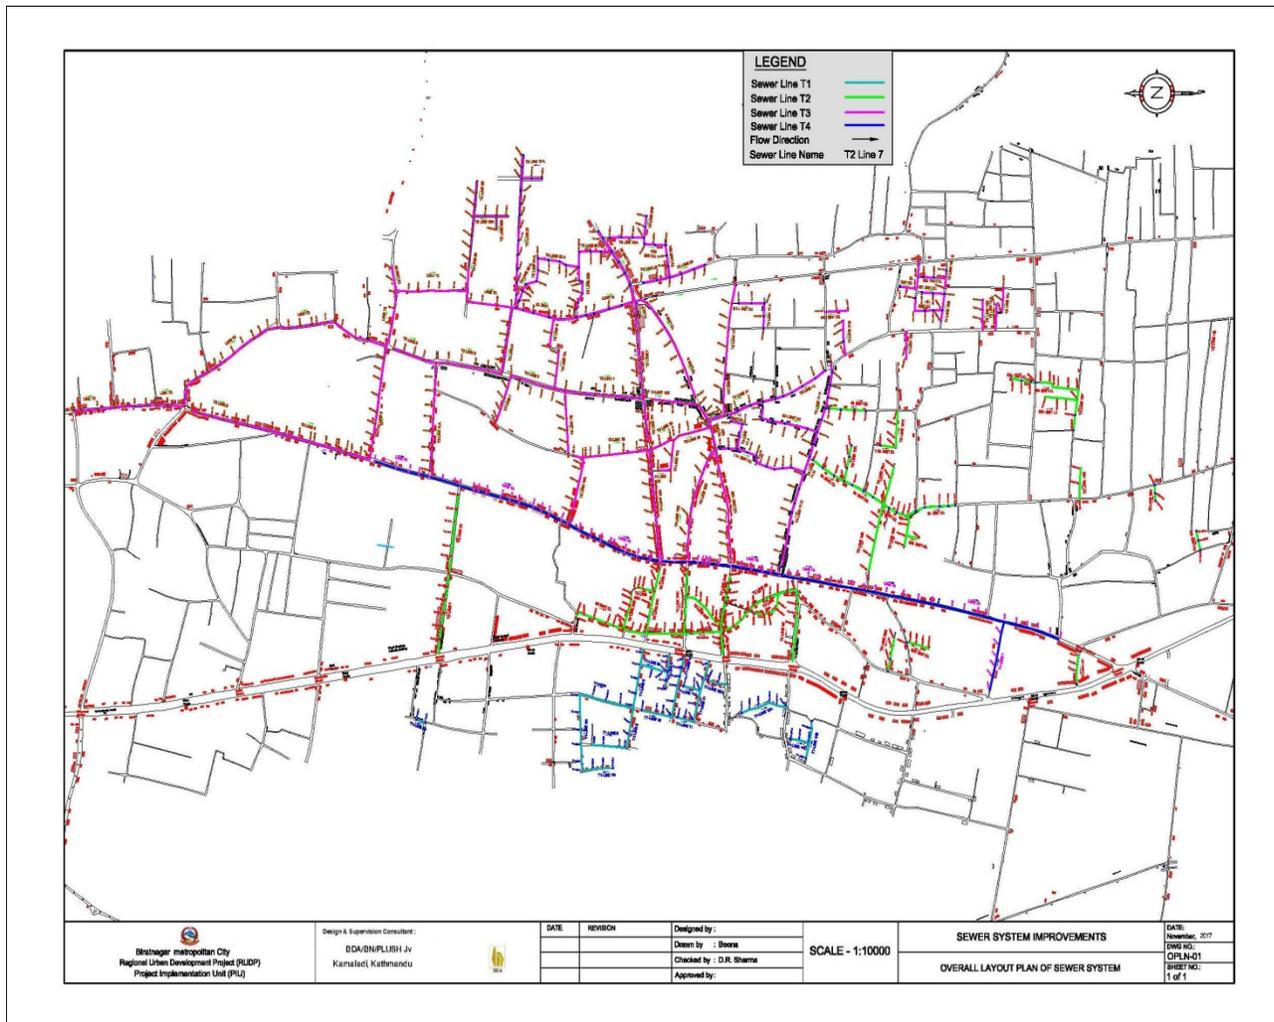
Figure 2: Sewerage Layout Plan

- 9 Total length of the proposed sewerage system will be 20.082 kilometers (kms). Similarly, 685 manholes are proposed in all sewerage sub systems. As indicated in design and drawings there will be 4 types of trunk and secondary sewerage system. Overall layout plan of the sewerage system as proposed for RUDP is given in *Figure 2*.

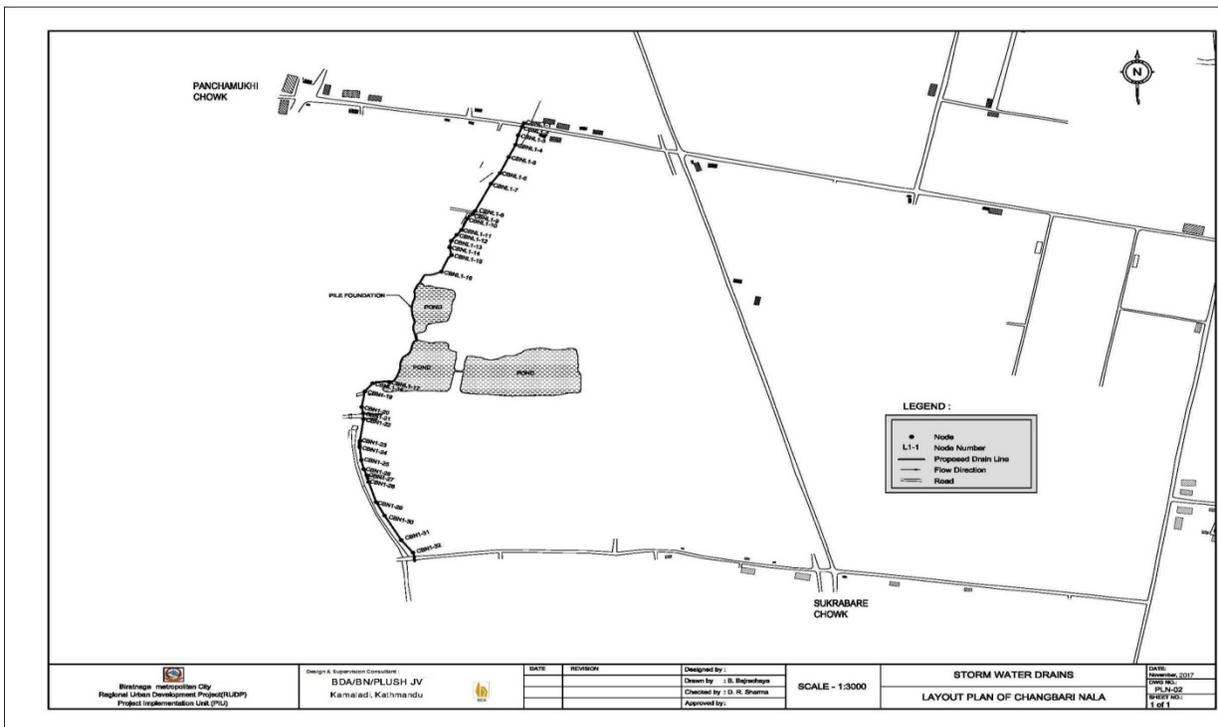
Figure 3: Storm Water Drainage Layout Plan

- 10 A total of 652.8m storm water drainage is proposed under the RUDP. *Figure 3* presented below shows overall storm water drainage plan for BMC. All planned drainage system has already been constructed by STIEUIP except for 652.89 m which passes through the existing Chyangbari Nala (Sagarmatha tole to Sukrabare Hatiya). The right side of blue shaded area in the *Figure 3* is proposed under the RUDP. The existing ROW of the drainage will be sufficient to improve the proposed section. There are no registered private lands, tenants and sharecroppers or seasonal encroachers at either site of the proposed drain.

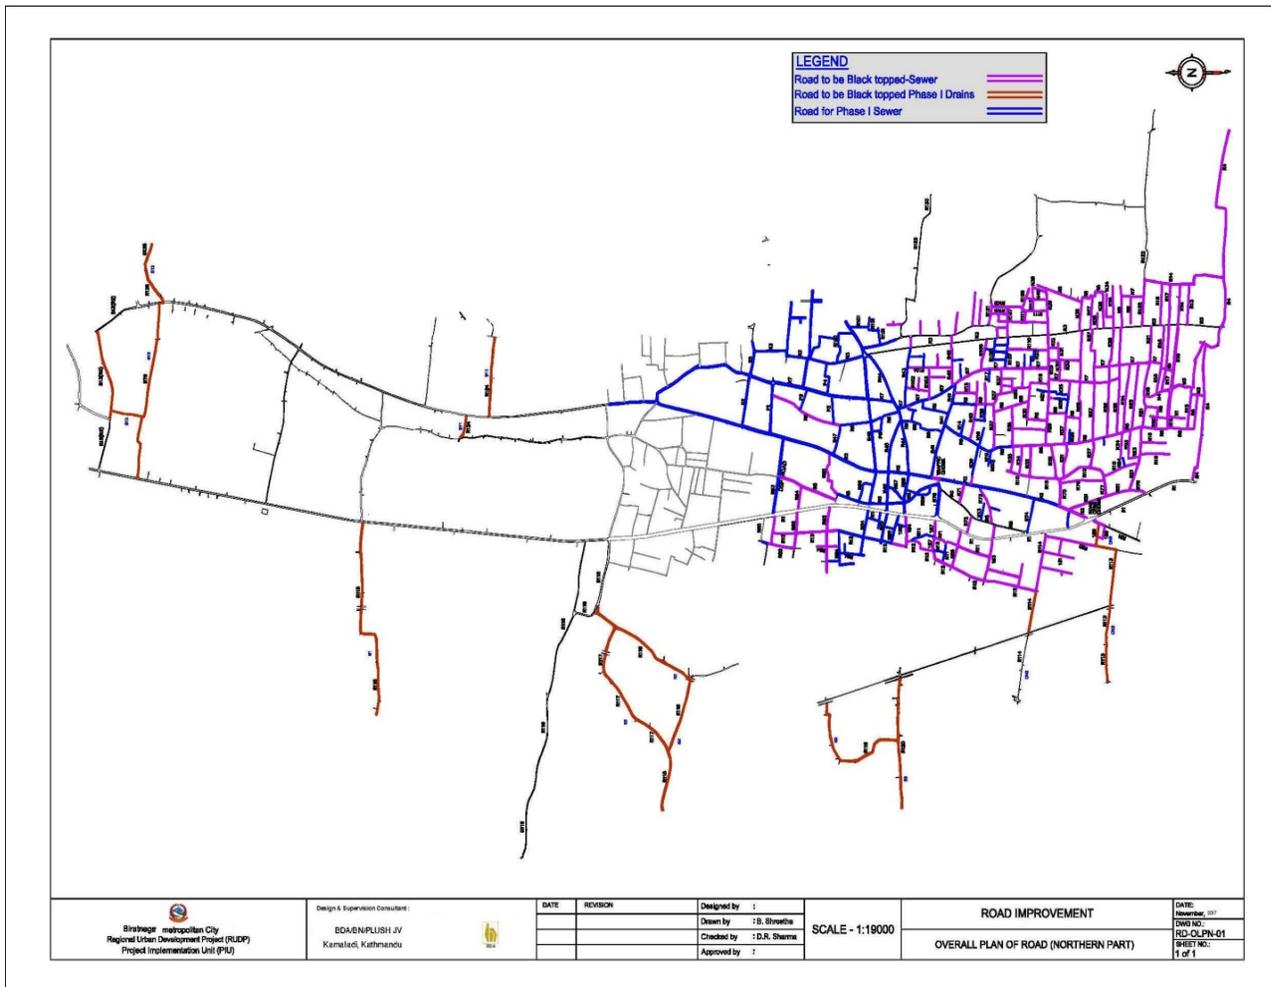
Figure 4a: Overall Layout Plan of Road Improvement Networks (Northern part/main road)

11 A total of 74 km road improvement is proposed in the RUDP. The roads included for improvements are those roads which were damaged due to pipeline installation, storm drain construction and other project related works of STIUEIP and couldn't be restored due to unavailability of funds. The overall road network layout plan is shown in *Figure 4a and 4b*.

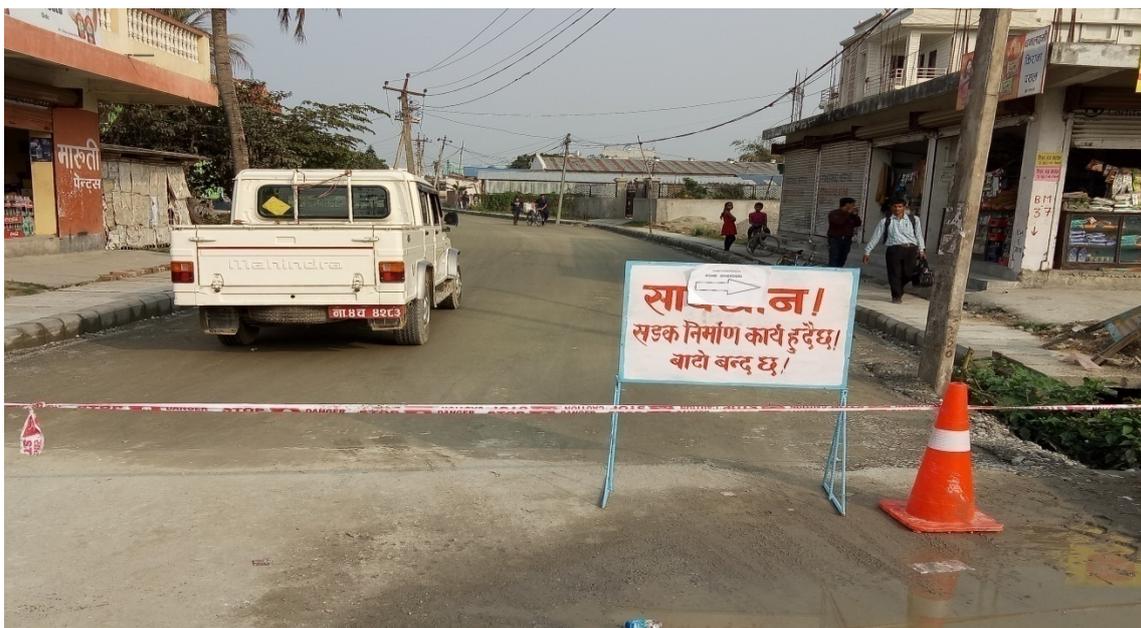
Photo 1: Sign board and barricade in Road section after laying of base course and making ready for asphalt concreting

26 Sign boards with barricades were installed at construction sites, however these are not sufficient. Therefore the contractor is requested to install adequate signboards with safety information, barricade and caution tape for demarcation of project site and its enclosure. Safeguard tools like helmets, gloves, boots and masks have not been adequately used by the labours.

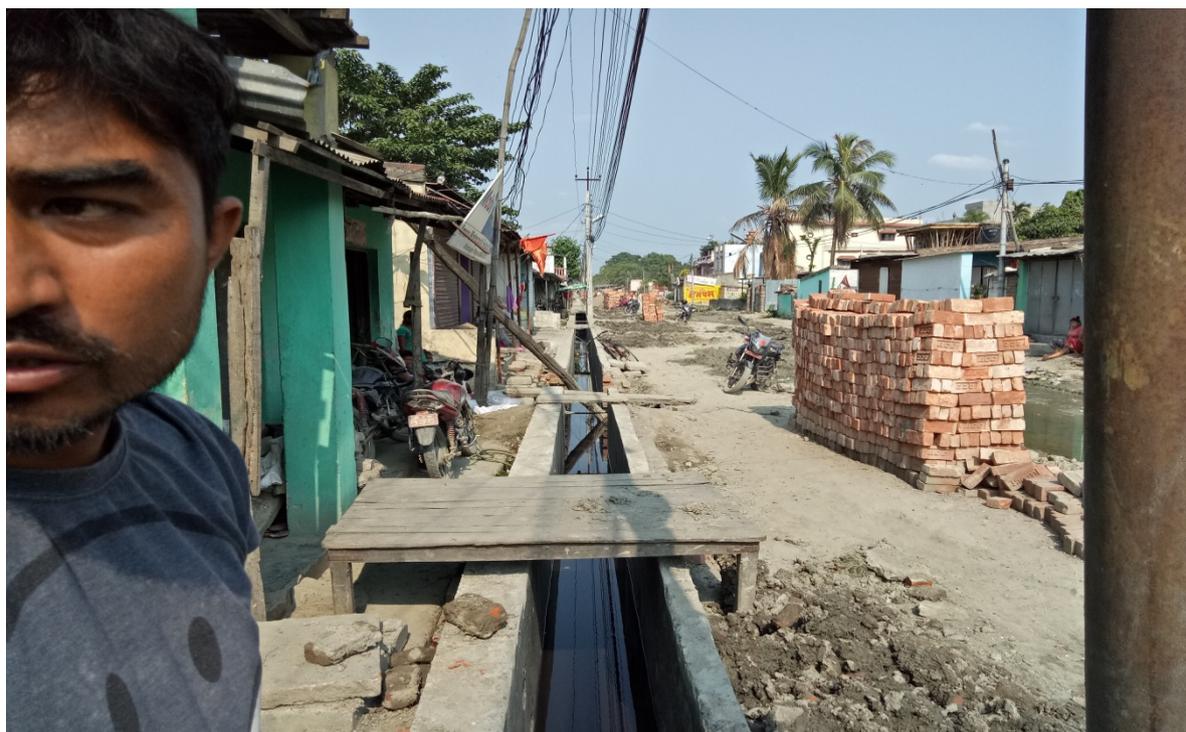
Photo 2: Open Road Side Drain at DSP road section

Similarly constructed road side drain left open at few road sections, where there may be problem for pedestrian and may chance of falling of pedestrian into drain. Therefore contractor instructed to cover the open drain immediately with slab cover.

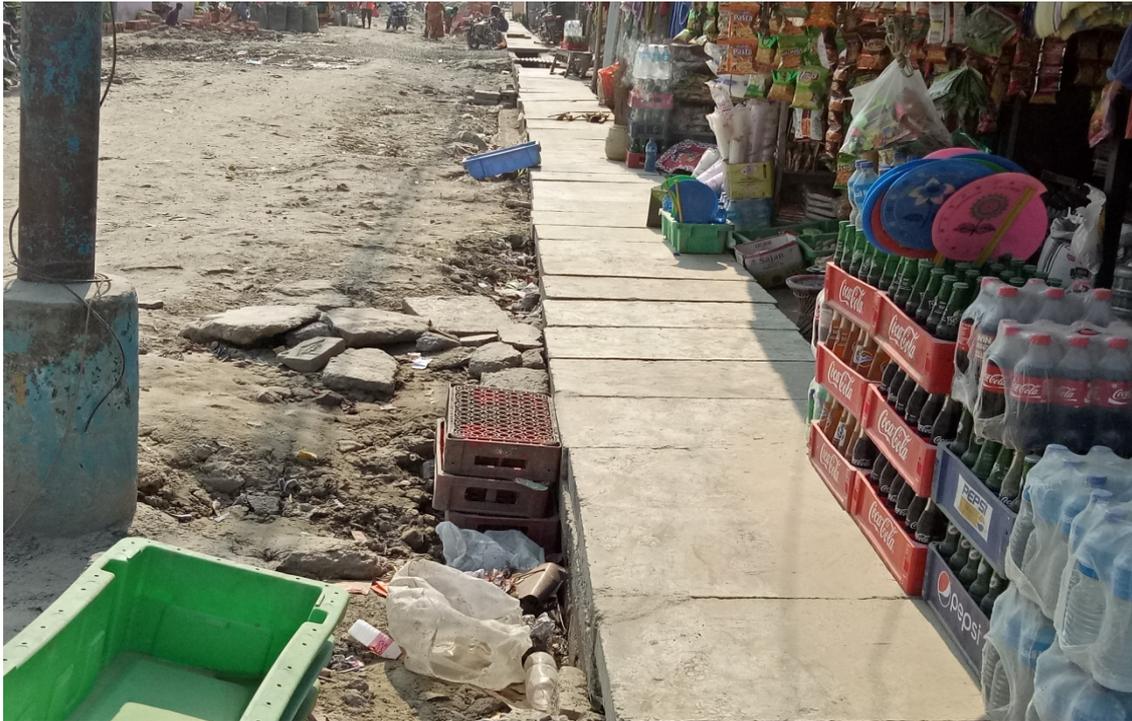
Photo 3: Road section with drain cover at DSP road section

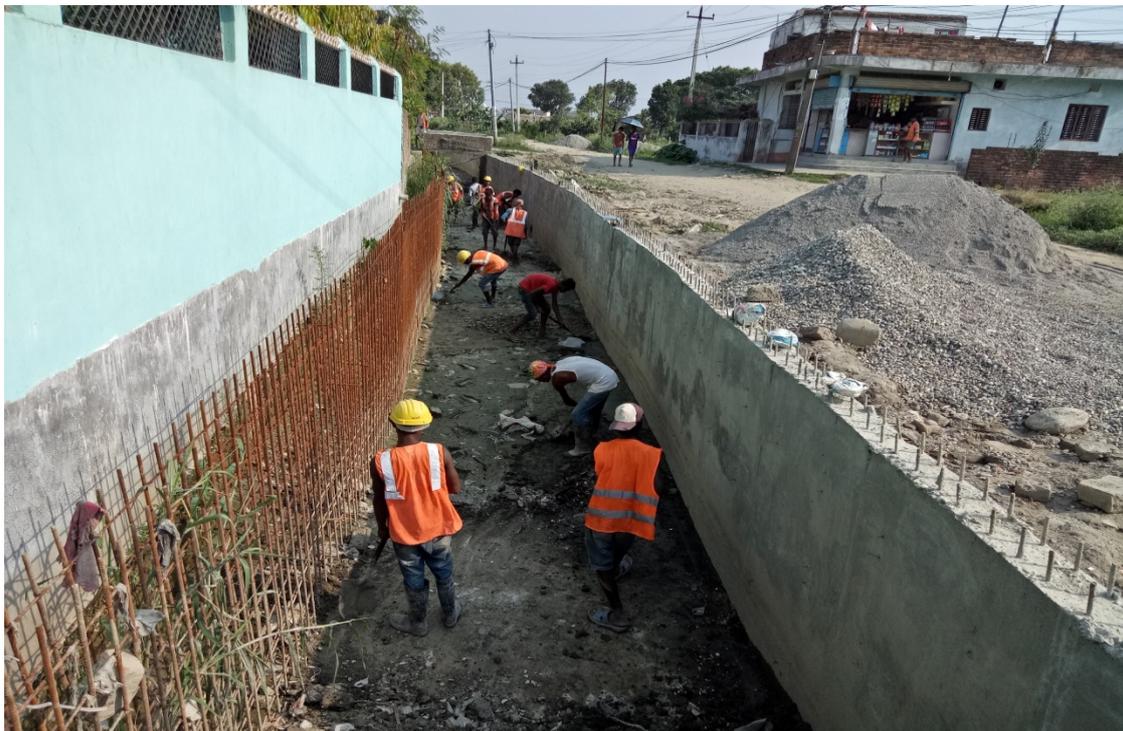
Photo 4: Labour working at Storm drainage at Chyangbari

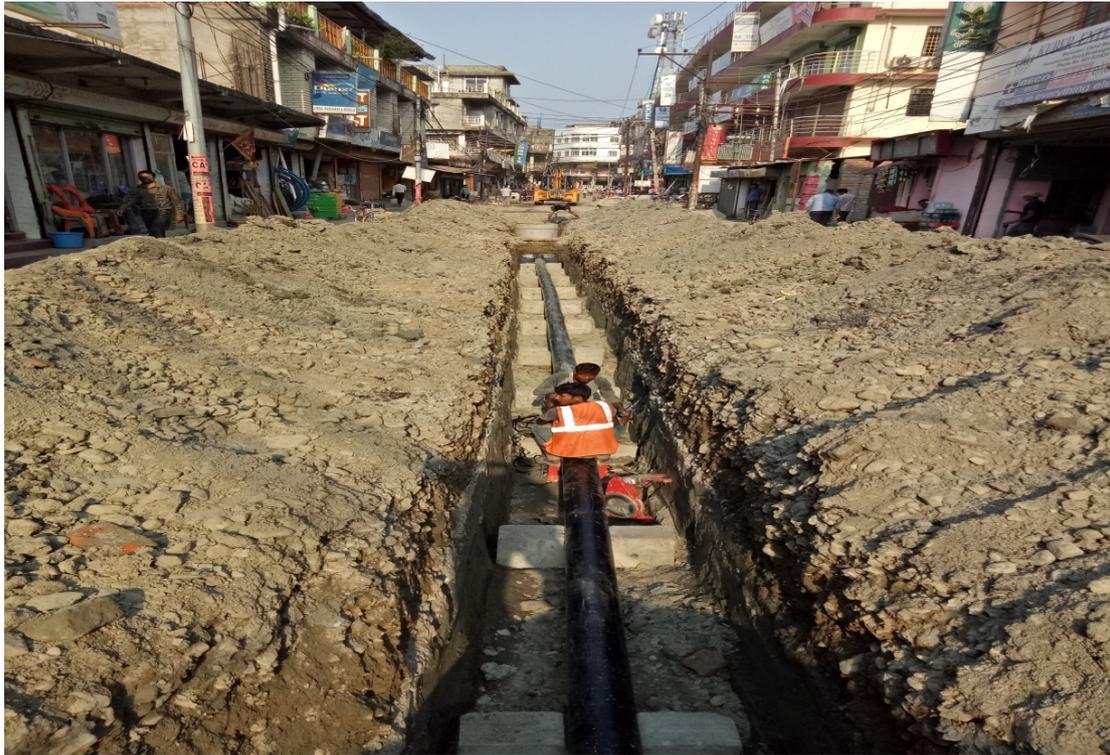
Photo 5: Laying of Sewrerage line along Hanuman Das road section

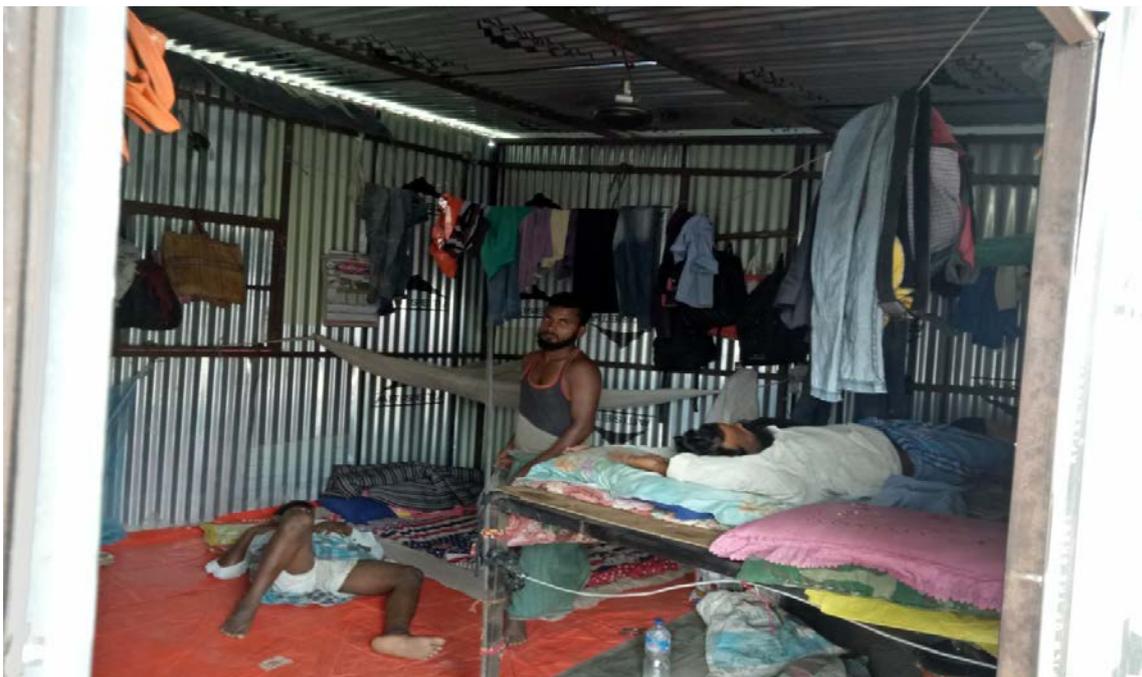
Photo 5: Labour camp(CGI sheet) at Asphalt plant area (Rani) with ceiling fan, mosquito net and solid floor
